**EXTERNAL AUDIT REPORT IN FULFILMENT OF THE
ENVIRONMENTAL AUTHORISATION FOR THE
REHABILITATION OF THE VAAL WASTE DUMP SITE
AT
ARCELORMITTAL SOUTH AFRICA
VEREENIGING WORKS**

Report Nr: 296-ZANAMVE-2015

Audit date: 9 October 2015
Report date: 23 October 2015

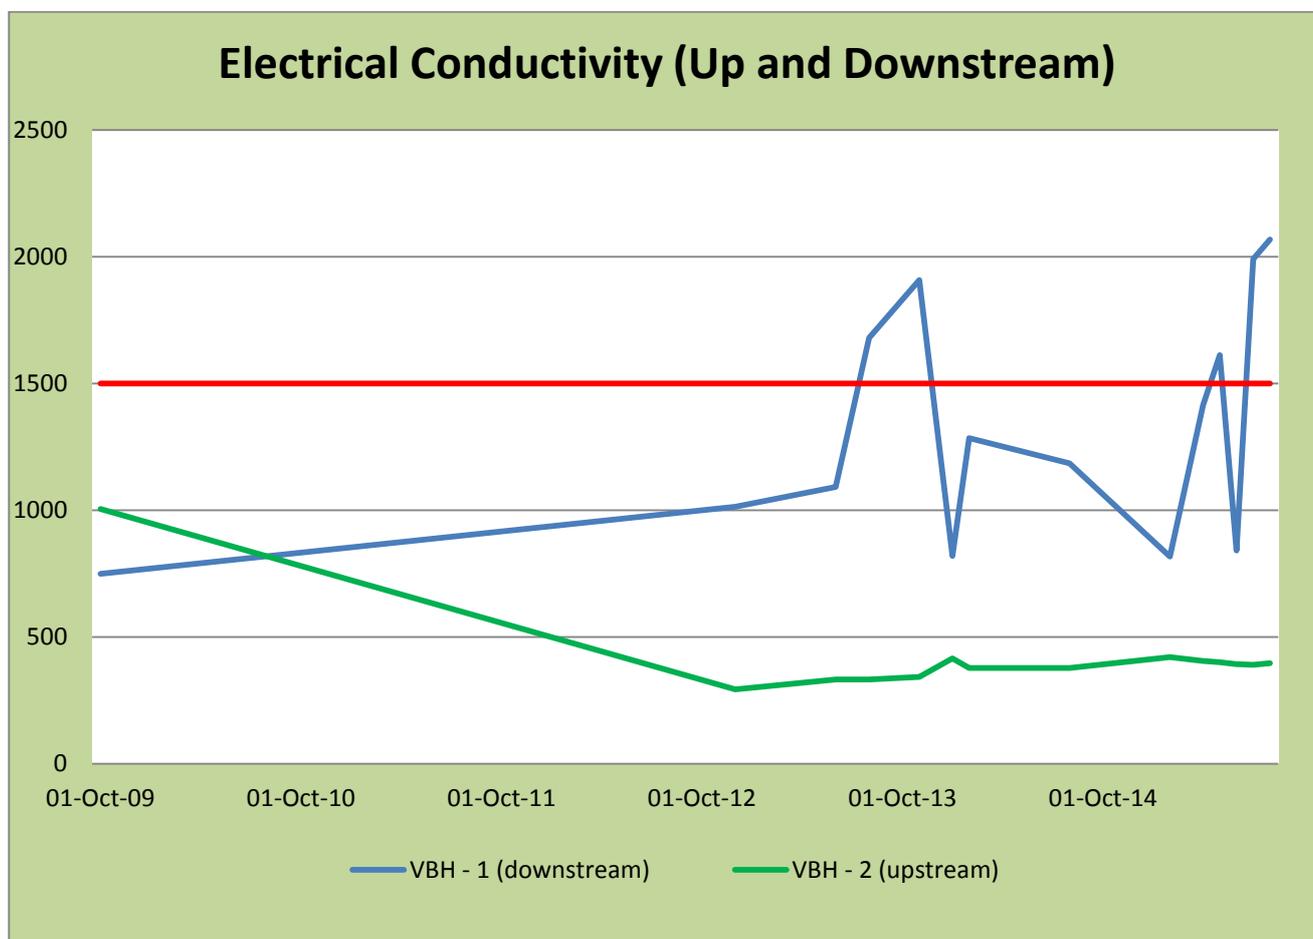
The borehole monitoring results show an increase in Electrical Conductivity (EC) from the upstream to the downstream boreholes (Figure 1) which correlates with the increased SO₄ concentration up and downstream of the site (Figure 2). Generally, the trend shows that the EC remains below the screening value for drinking water as prescribed by SANS 241:2011. The trend shows a spike in EC in 2013 and 2015. Moreover, the monitoring results show higher EC in the deep aquifers adjacent to site compared to the medium depth boreholes adjacent to the site Figures 3 and 4.

Figure 1 Up and downstream borehole monitoring results (electrical conductivity)

Zantow Environmental is of the opinion that ground water sampling should be done on a bi-annual basis as the frequency is more in line with acceptable ground water sampling best practise. Ground water is a slow moving process and monthly sampling is excessive. The elements to be samples should also be stated in the monitoring program and unnecessary analysis excluded.

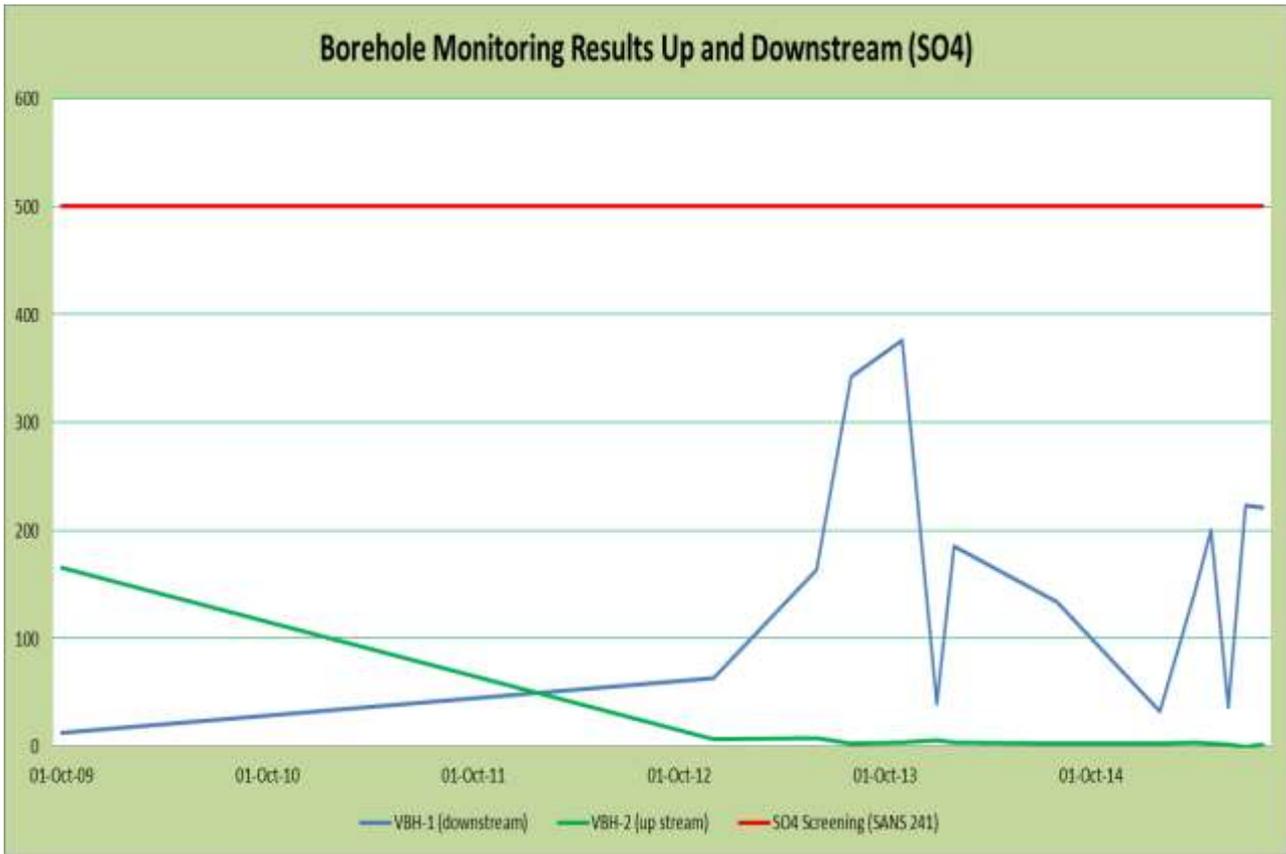
Figure 2: Up and downstream borehole monitoring results (SO4)

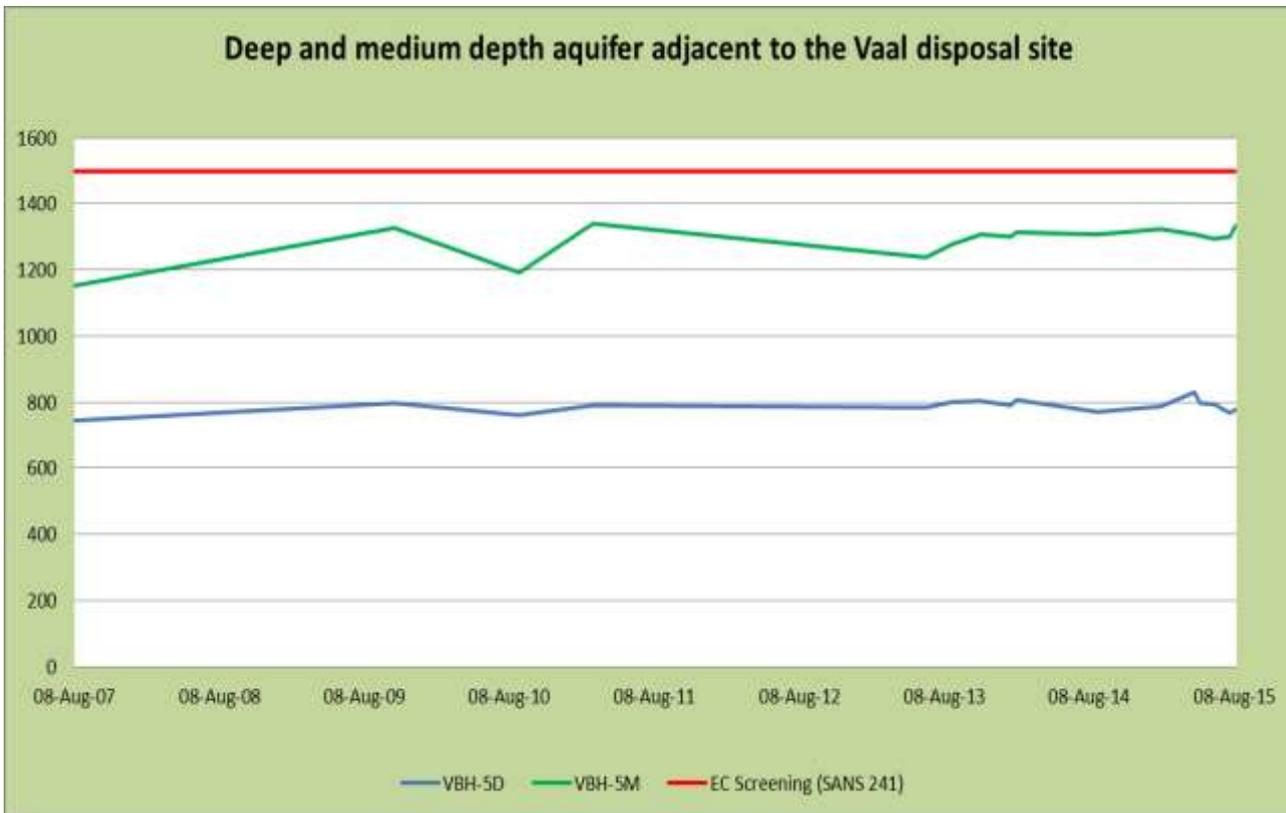
Figure 3: Borehole monitoring results (deep and medium depth adjacent to the site VBH-5D and VBH-5M)

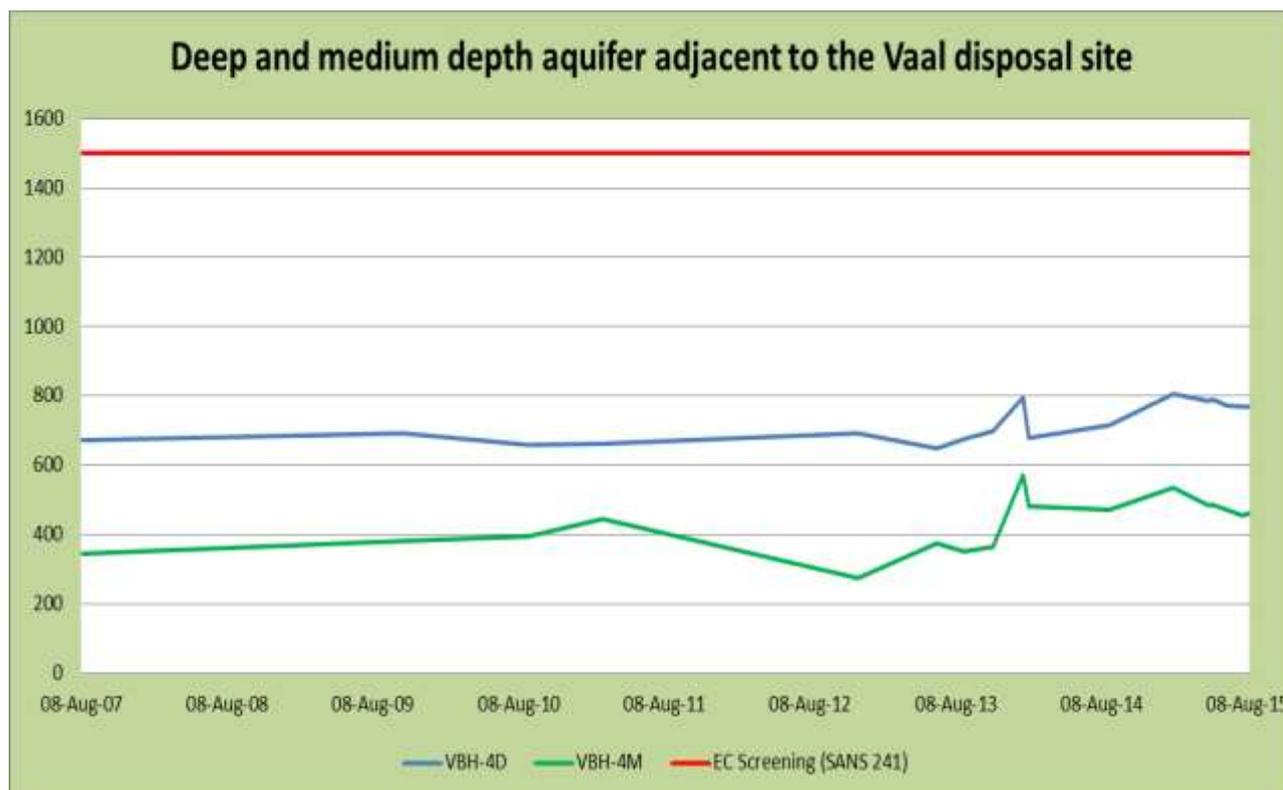
Figure 4: Borehole monitoring results (deep and medium depth adjacent to the site VBH-4D and VBH-4M)

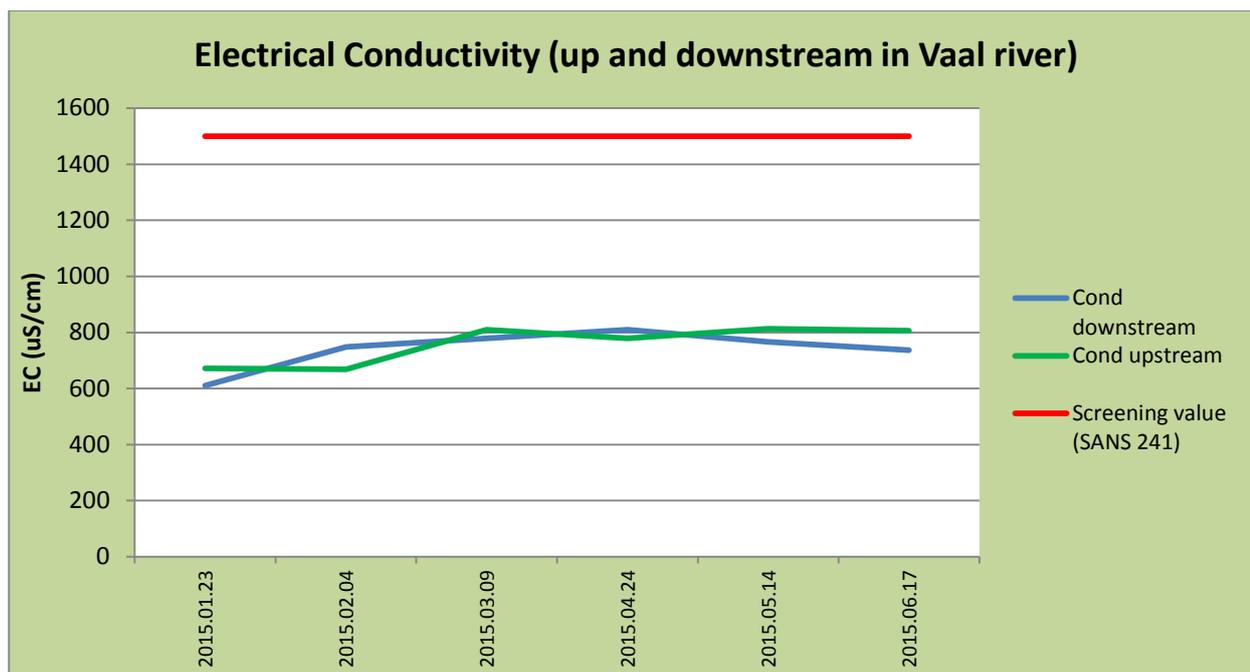
Monthly monitoring is conducted at locations up and downstream of the Vaal disposal site in the Vaal River. There is no significant increase in EC downstream of the site compared to the upstream analysis (Figure 5). One sample was taken and analysed in April for stormwater channels up and downstream of the site. Other samples were not taken due to a lack of water in the channels. The analysis of the sample showed no significant increase in EC up and downstream in the adjacent to the site.

Figure 5: Surface water monitoring (up and downstream of the site in the Vaal River)

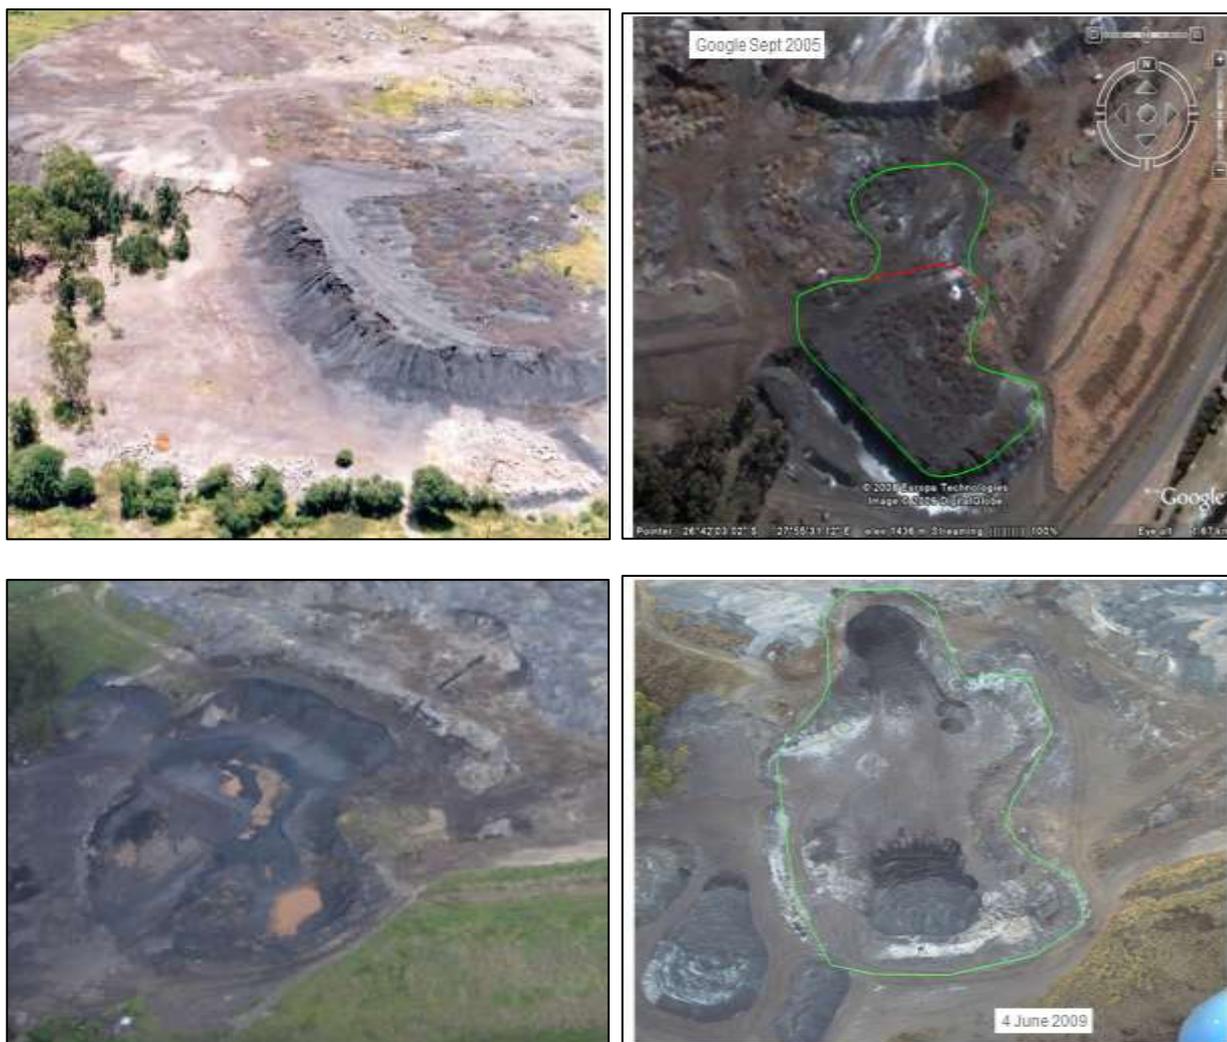
ArcelorMittal commenced with remediation of the Vaal Disposal Site in 2006. The authorities instructed ArcelorMittal via a directive to cease with all operations and submit an amended Remediation Plan for approval by GDARD and DEA. ArcelorMittal submitted an amended plan in January 2008 and GDARD approved the remediation plan in 2011 but DEA has not approved the amended remediation plan to date. The parties are disputing the need for ArcelorMittal to apply for an additional Waste Management License in terms of the new legislation. No remediation occurred since after the removal of the magnetite in 2009.

Photo 1 -4 Progressive removal of Magnetite from the Vaal Disposal Site

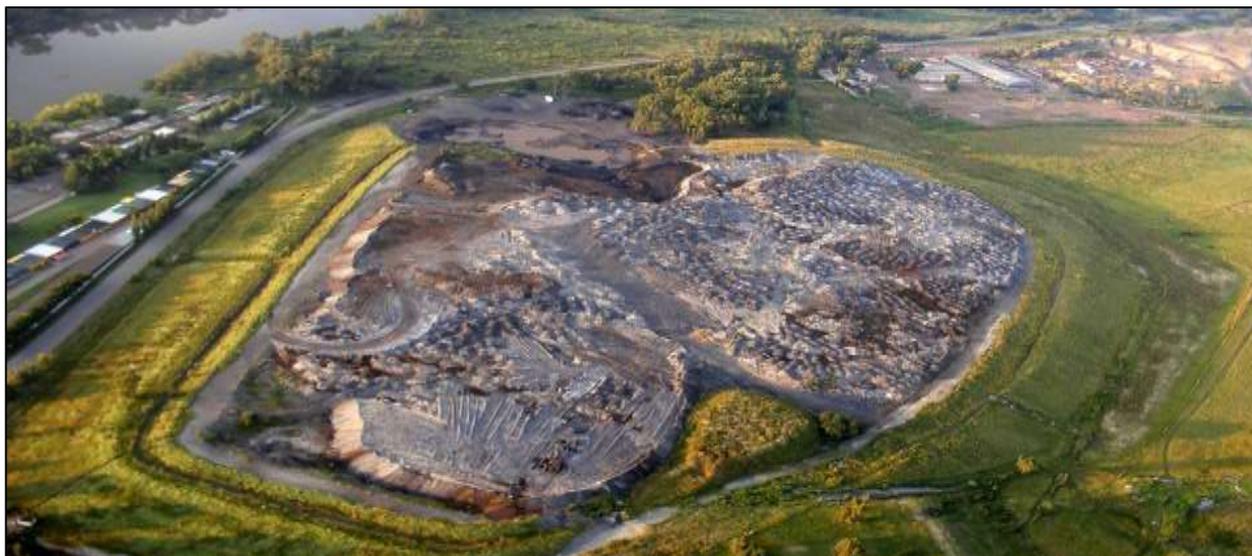
The side slopes of the disposal site have been capped and vegetated with proper storm water controls implemented. During the site visit the side slopes were observed to be stable and no erosion noted. The storm water drainage system seems to be effective in management of runoff water. The vegetation was also noted as being effectively established. Some invader species were noted on site and must be addressed on an on-going basis.

Photo 5 Capping layers on side walls and vegetation growth

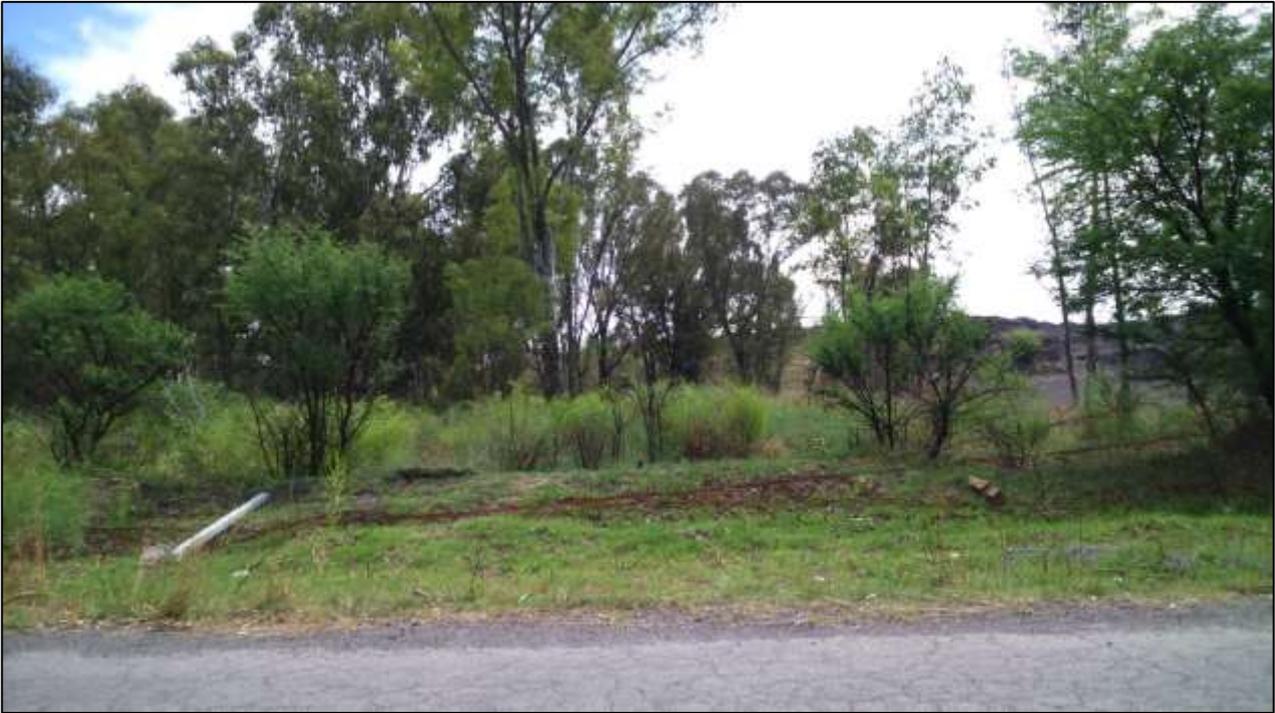
EMP and Operational Plan	Findings or Comments
Site boundaries	At the time of the audit it was found that the site boundary fence has been compromised and access control to the site is therefore not effective. Refer to Appendix A for a photo of the broken fence. It is recommended that ArcelorMittal repair the site boundary fence to reinstate effective access control to the site
Fuel and Oils	No oil stored on site
Ablution facilities	No personnel on site. Mobile units were used on site during operational phases
Eating Areas	No personnel on site
Solid Waste Management	No activity on site
Site Structures	The areas looked neat and organised
Fire control and Emergency Procedures	Fire fighting equipment not observed on site. Emergency contact details were found to be in place and displayed
Accidental leaks and spillages	None observed
Dust management	No activity on site no dust observed
Noise	No activity on site

Broken fence
