**EXTERNAL AUDIT REPORT IN FULFILMENT OF THE
ENVIRONMENTAL AUTHORISATION FOR THE
COKE OVEN CLEAN GAS AND WATER PROJECT
AT
ARCELORMITTAL SOUTH AFRICA
VANDERBIJLPARK WORKS**

Report Nr: 495-ZANAMSA-2016

Audit date: 19 August 2016

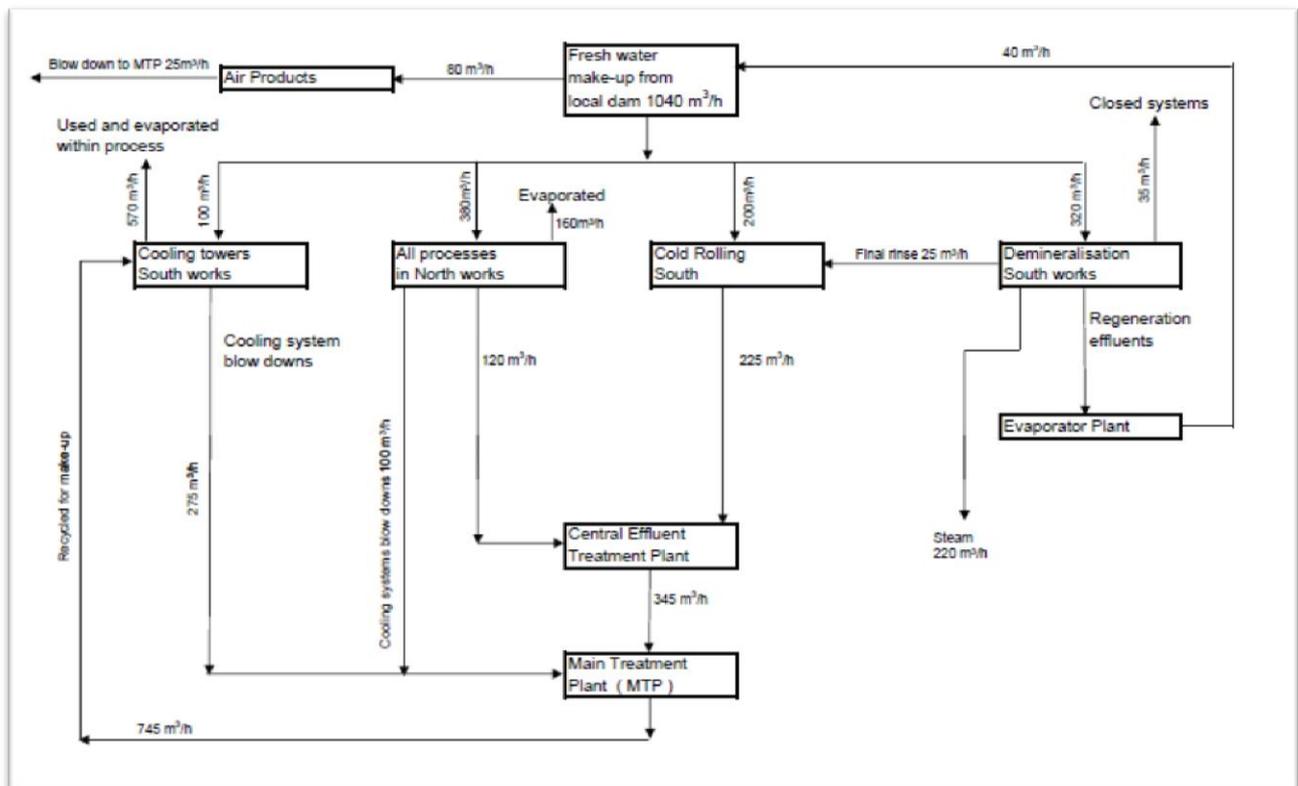
Figure 1 Updated Vanderbijlpark Works Water Balance

The facility constructed and commissioned the Main Treatment Plant (MTP) as well as upgraded the existing Central Effluent Treatment Plant (CETP) in December 2005. This enabled ArcelorMittal Vanderbijlpark Works to significantly decrease the raw water abstraction with approximately 50%. The MTP enabled ArcelorMittal Vanderbijlpark Works to treat its process effluent water that was previously discharged subject to the Water Use Licence applicable at the time. After treatment, the water is re-used in the process. The facility has maintained their zero effluent status until 2011 when the system could no longer cope with the demand for high quality water and the excess low quality water was discharged. The discharge continued until end of July 2012 where after the zero effluent status was re-instituted. The facility installed additional salt removal capacity and made various process changes in order to optimise the system and reported during the audit that the water balance of the Works are not very tolerable of upsets. The updated water balance for the Works is illustrated in the figure below.

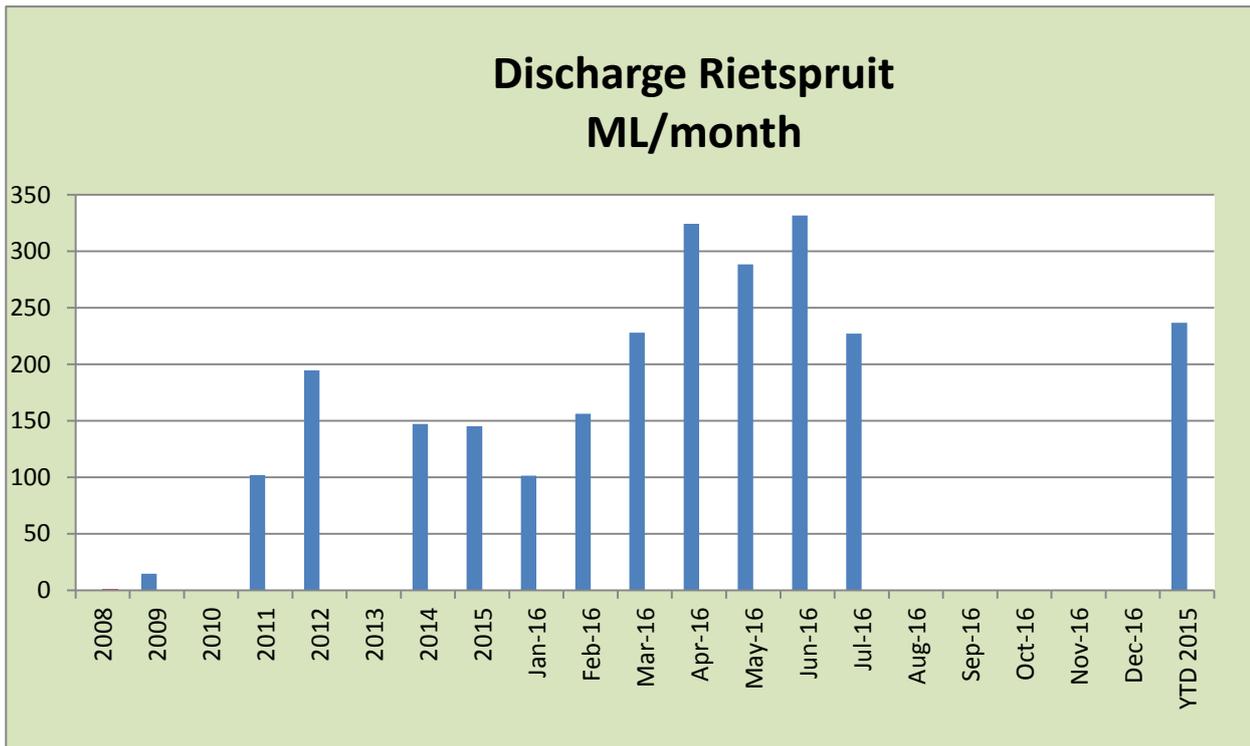
Figure 2: Effluent discharge volume

As can be seen in Figure 2, there was some effluent discharged in 2016 to date. The facility reported the relevant discharges to the competent authority and the matter falls outside the scope of this audit. Not specifically related to the project.

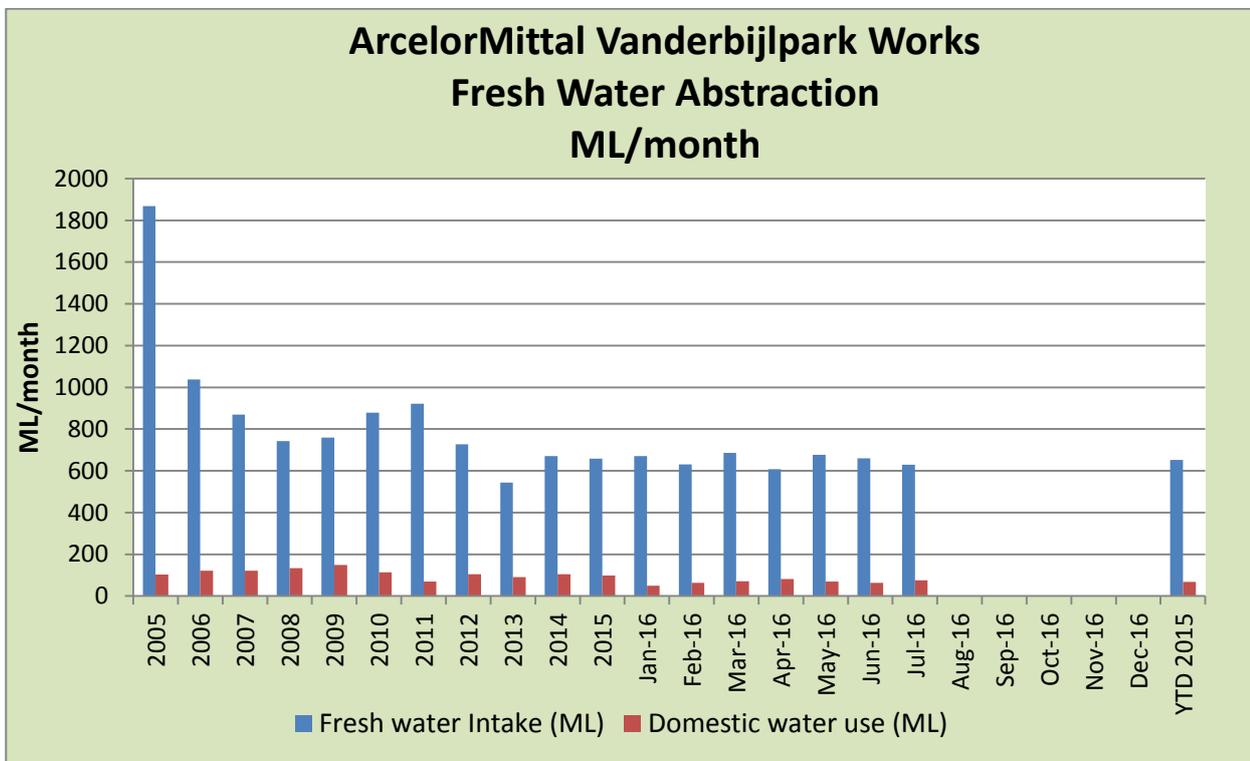
Figure 3: Fresh water abstraction

As illustrated in Figure 3, an average of 65% reduction of water abstraction since 2005 has been achieved.

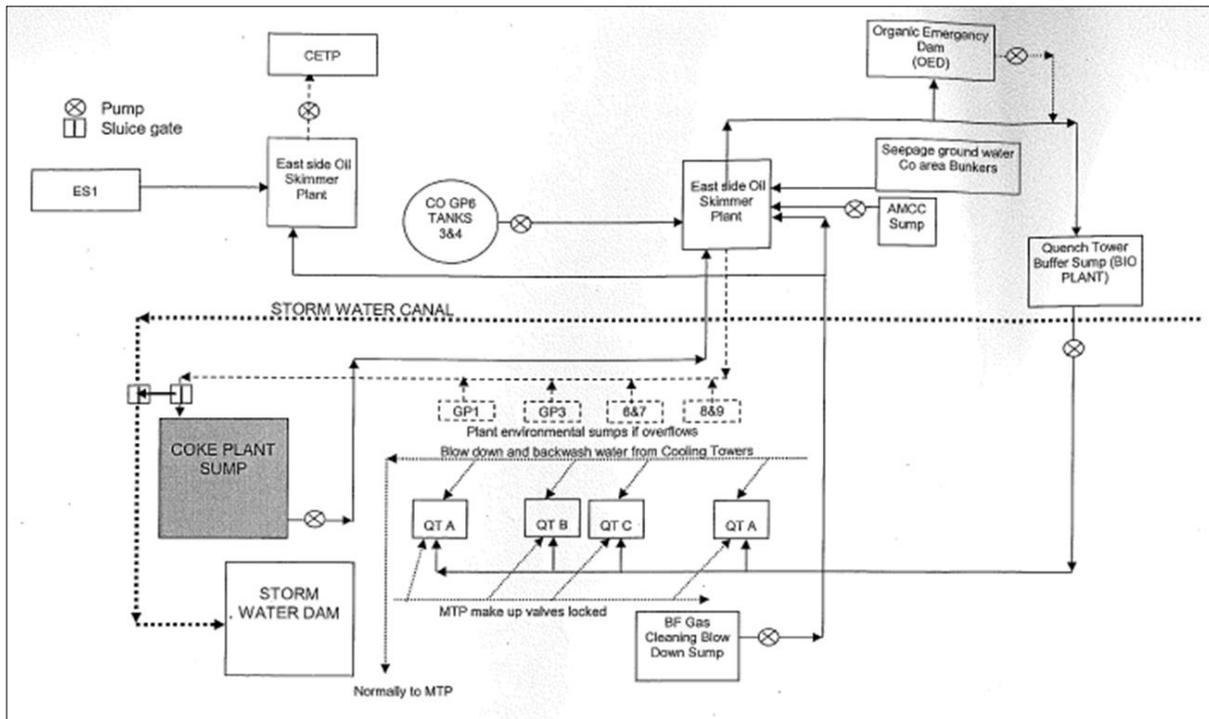
Figure 4: Coke plant water balance

The coke ovens are however only a portion of the facility's water balance. The coke ovens create coal water as a by-product from the reduction of the coal to coke. The coal water and other sources of effluent water are directed to the oil skimmer where some mechanical oil skimming occurs. The effluent is then pumped to the quench tower quench tower sump and used as quenching water.

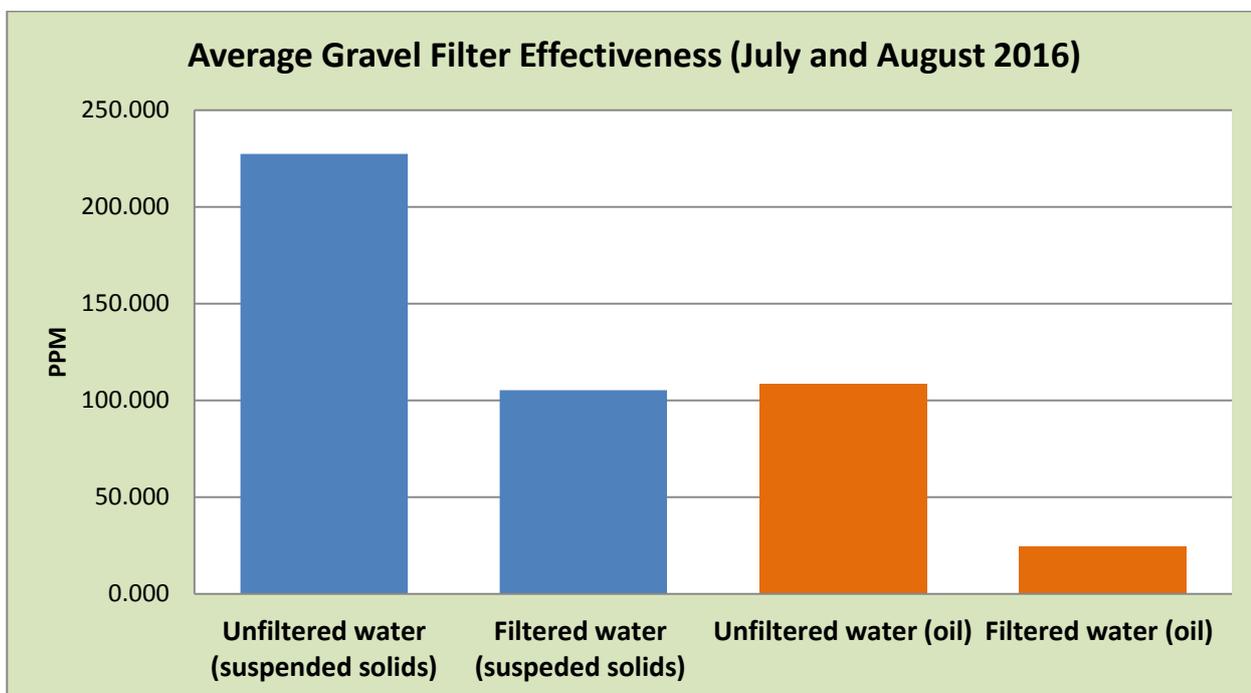
Figure 5: Gravel Filter SS and oil removal – 2016

The Gravel Filter plant has been installed and commissioned in 2013 and the treatment of waste water in this process is shown to be effective. The gravel filter plant is part of the original design scope of the project to clean the coal water in order to avoid quenching with dirty water and enable the potential re-use of the treated coal water in the BF Gas cleaning plant.

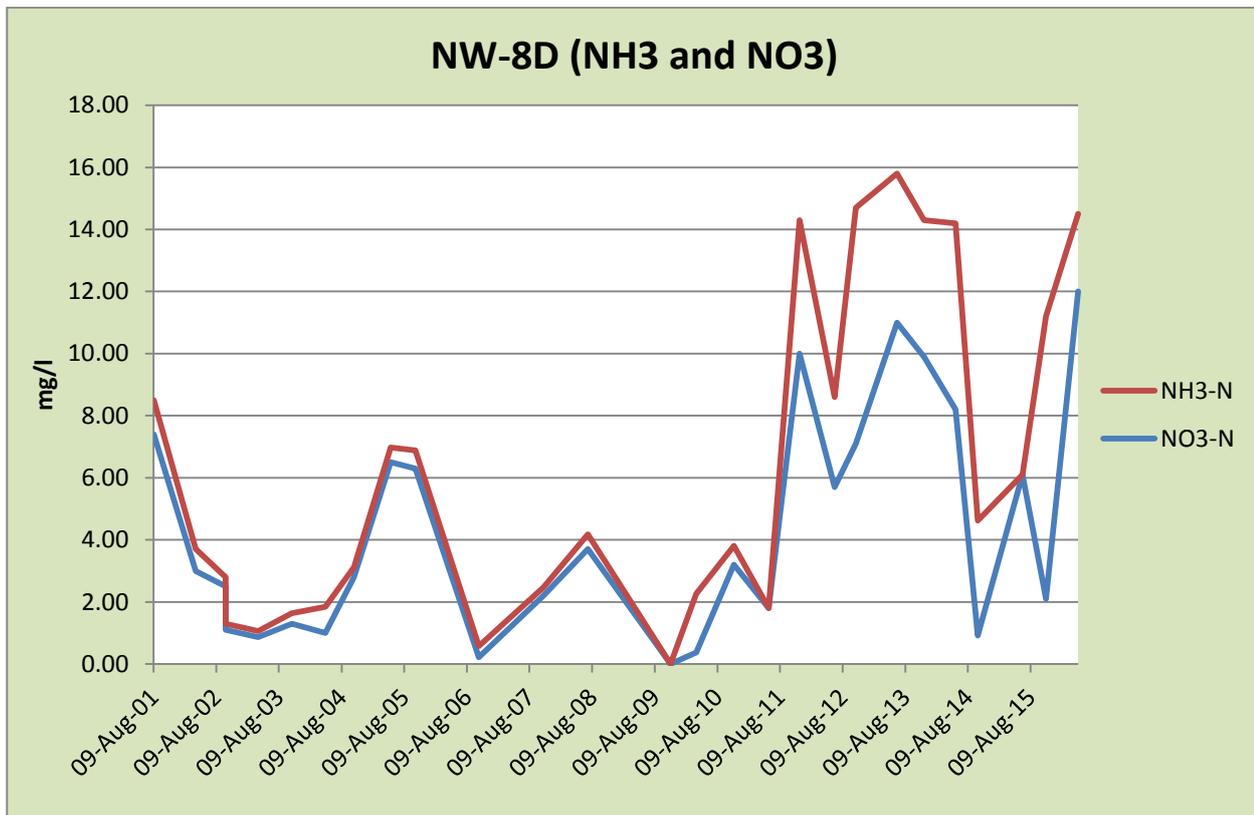
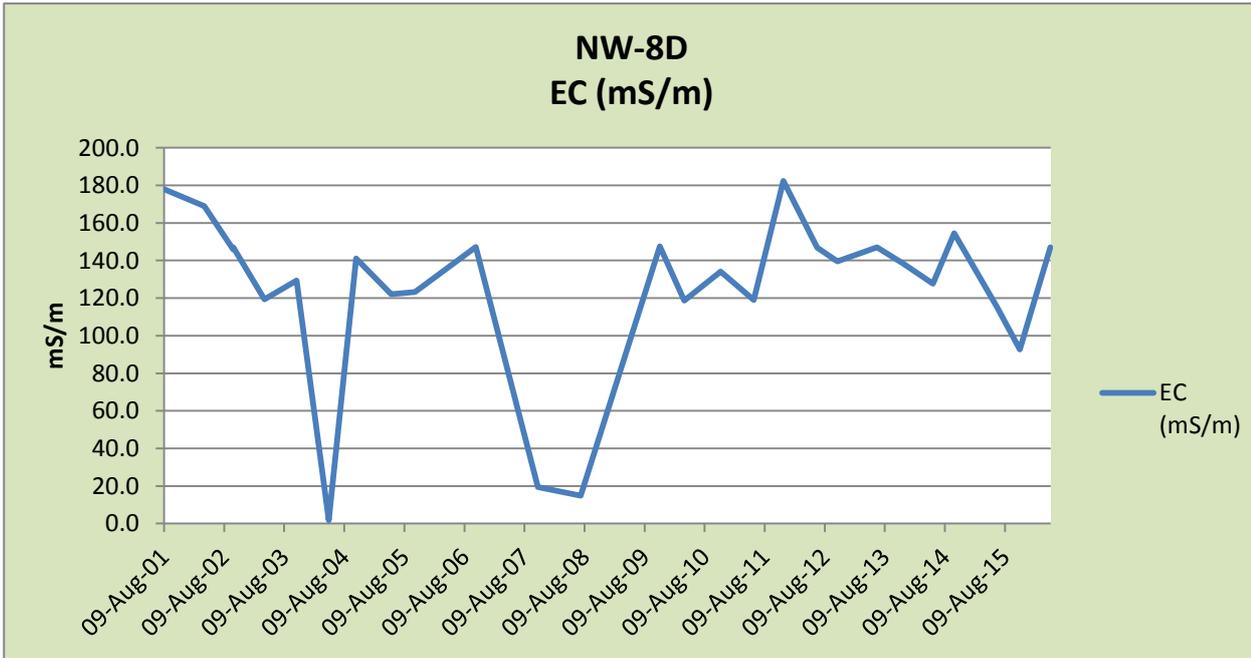
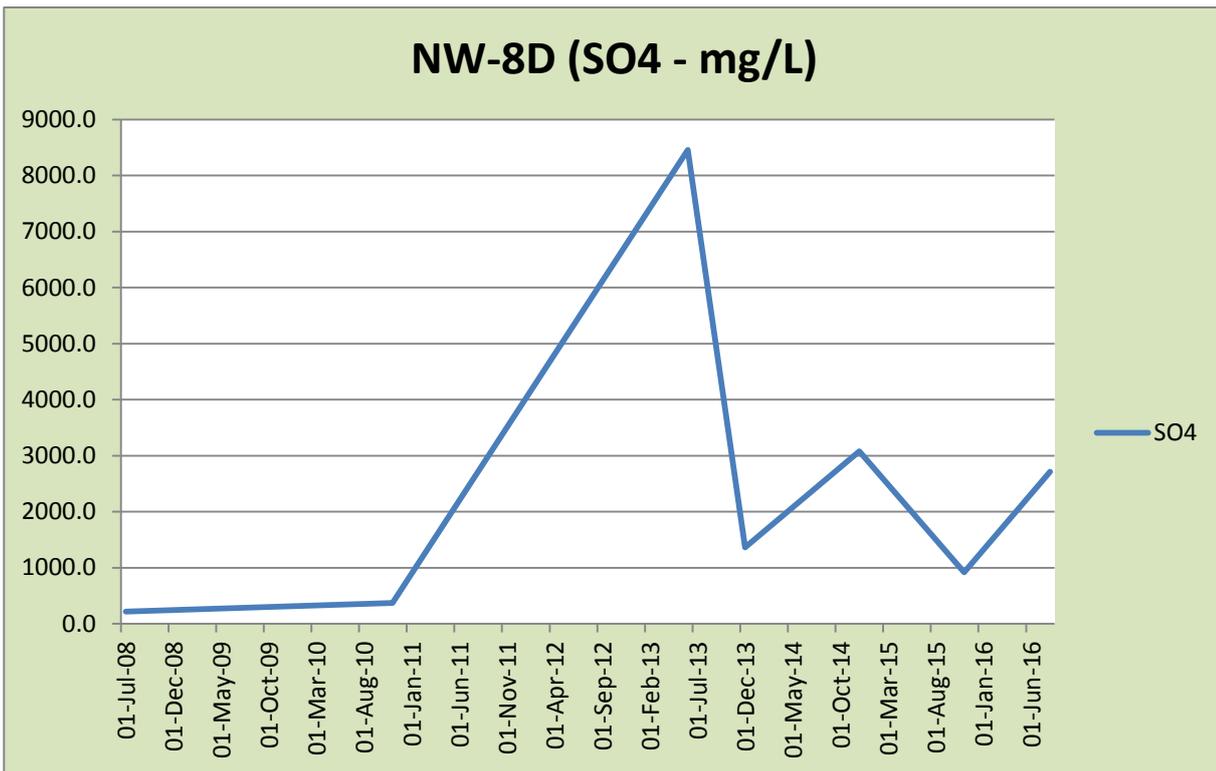
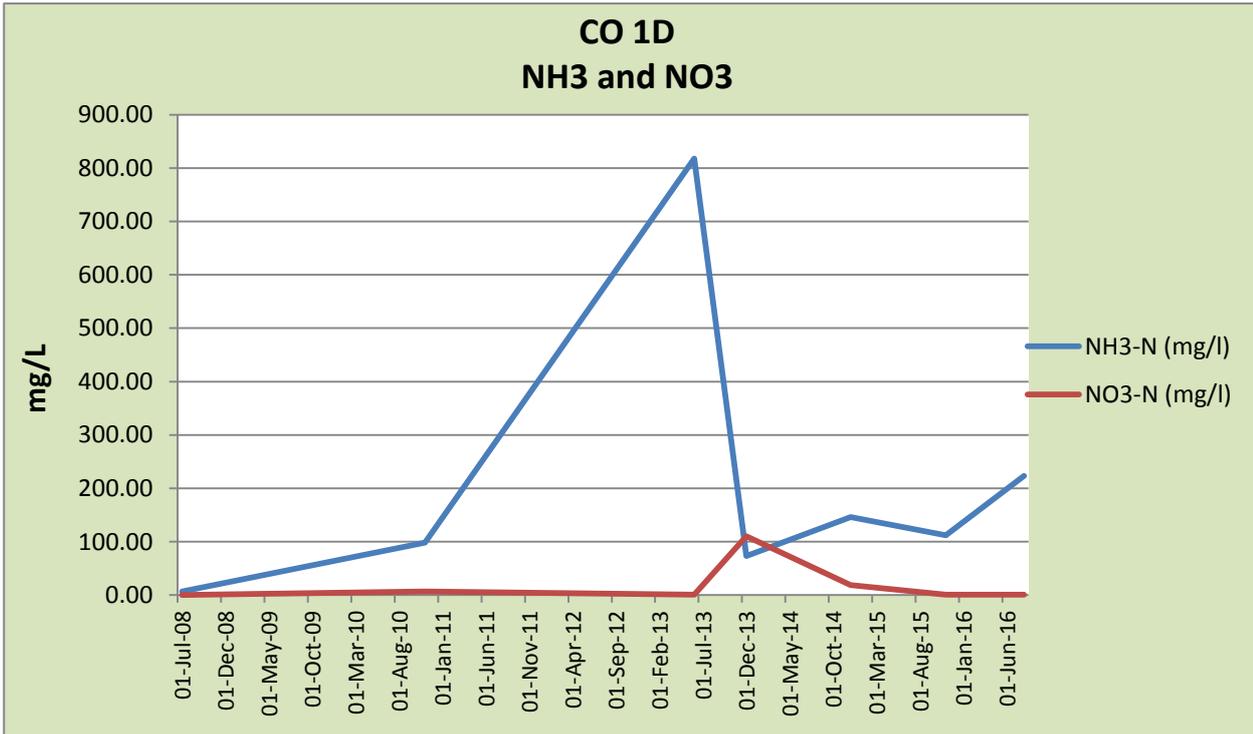
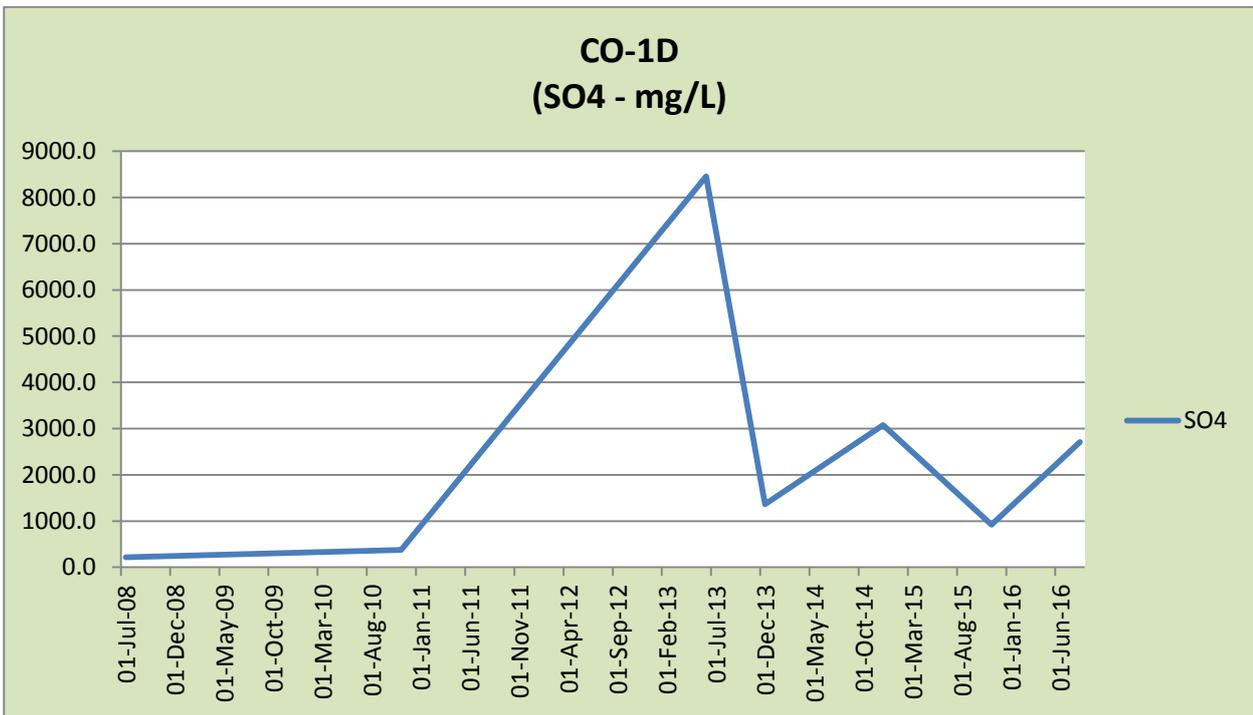
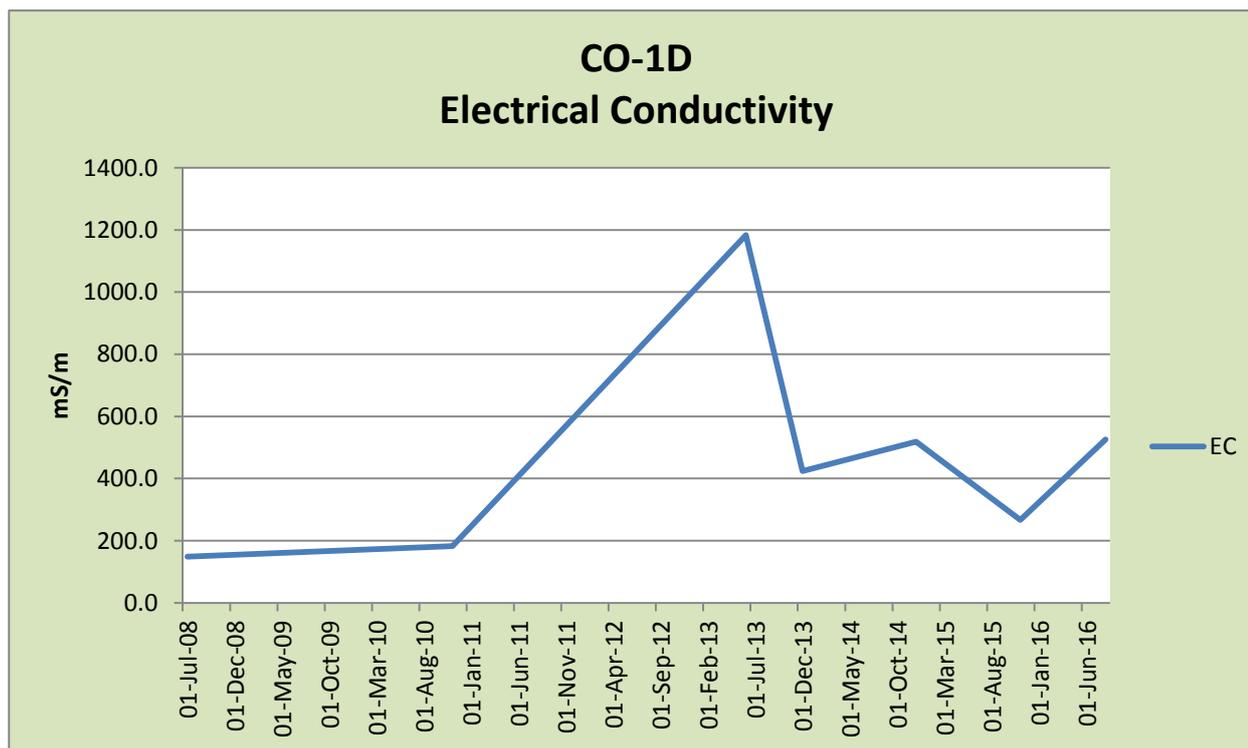
Figure 6: NW-8D NH3 and NO3

Figure 7: NW-8D Electric Conductivity

Figure 8: NW-8D SO4

Figure 9: CO-1D groundwater data (NH3 and NO3)

Figure 10: CO-1D ground water data (SO4)

Figure 11: CO-1D ground water data (EC)

From the analysis, it is clear the groundwater qualities in the specific areas are highly variable. This is expected according to the Groundwater Management Plan as the plume moves and dilutes over distances. The impact measured cannot be attributed towards the COCGAW specifically and from a source and scale perspective is most likely not the major cause of the poor quality.

- Monitoring of ground water at borehole CO-3D cannot be undertaken as the borehole no longer exists. Finalise the drilling of an alternative suitable borehole that could be used for the same purpose envisaged and align the relevant legal requirements. **(ArcelorMittal, October2016)**
- Exposure monitoring indicates that further fugitive emission mitigation measures are required. Although ArcelorMittal supplies specialised PPE and has implemented management measures to mitigate employee exposure, it is recommended that the additional fugitive emission reduction projects as identified by ArcelorMittal be prioritised and implemented. **(ArcelorMittal, as per project schedule)**

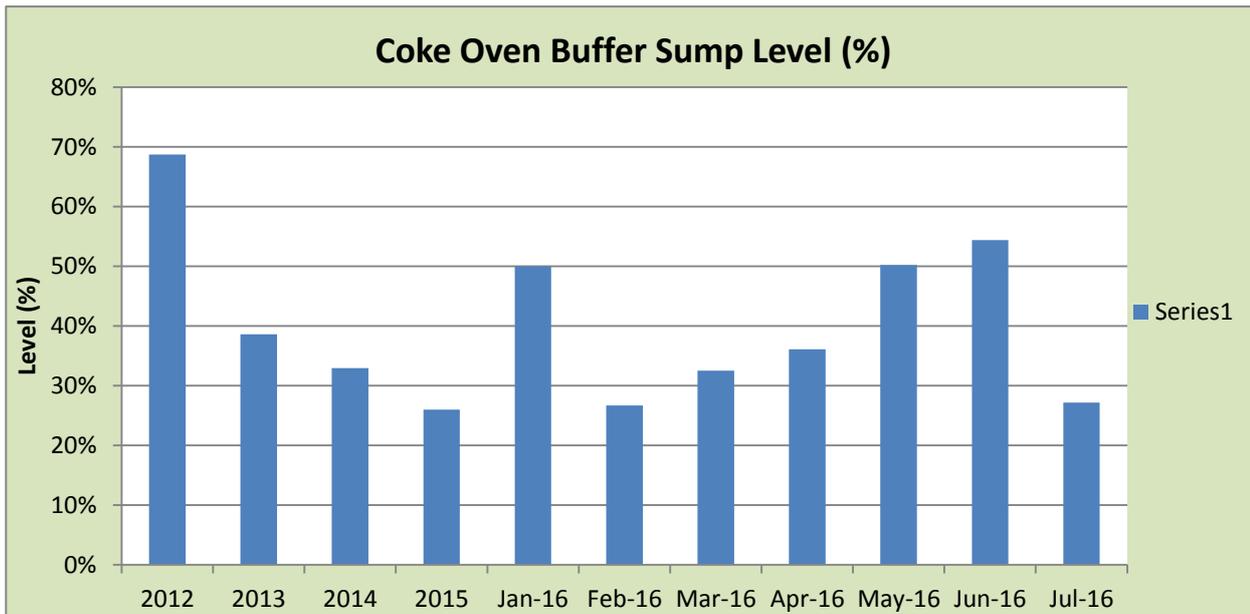
Figure 12: Coke plant sump level

In the event of process upset conditions, contaminated surface water can be diverted to the Coke Plant sump. The coke plant sump is a buffer dam and water from the dam can be reclaimed again for re-use as and when there is sufficient capacity in the system. The levels of the coke plant sump is managed and measured to ensure the sump does not overflow.

Clean storm water is measured at the coke plant storm water drain but is combined with other areas inflows. The flow is measured continuously and the EC is also monitored and used to detect potential spills into the storm water drains.

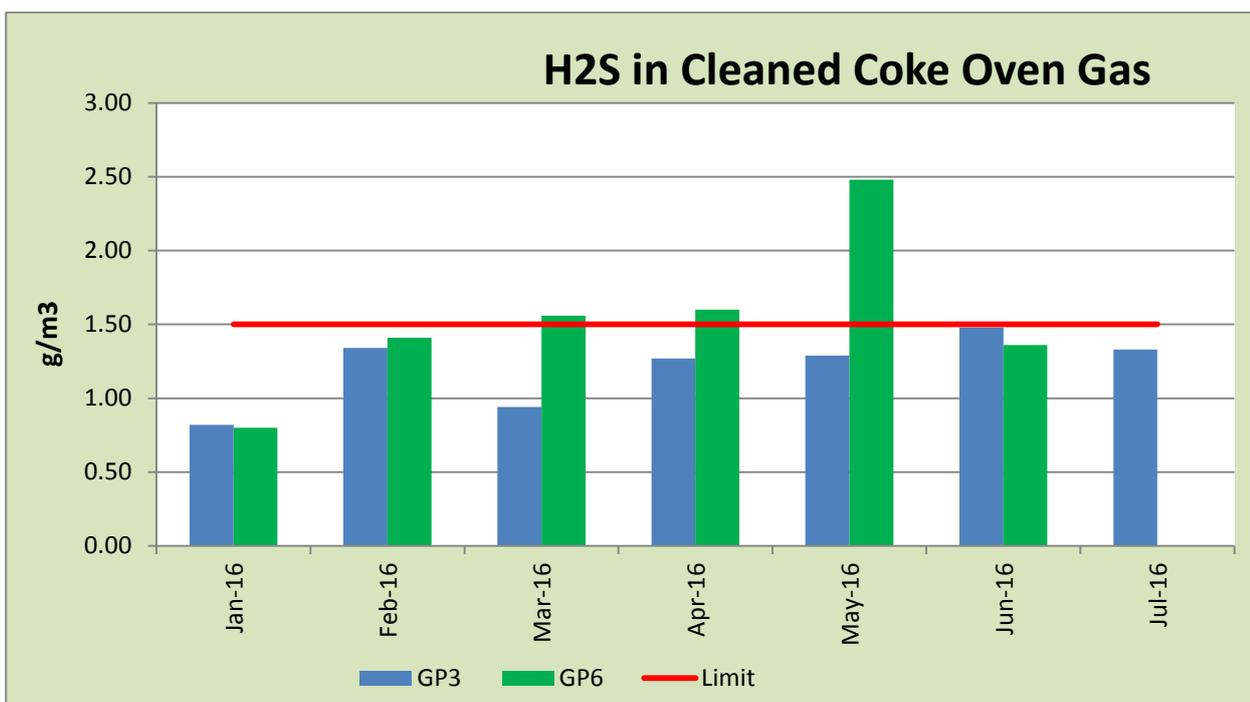
Figure 13: Coke oven gas quality

The COCGAW plant aims to remove impurities from the gas which includes the removal of sulphur in the Claus Reactor. Due to the fact that the plant is not operational sulphur removal does not occur and the H₂S concentrations in the Coke Oven Gas can be improved upon with re-operation of the Sulphur plant.

- Commission the Sulphur removal section of Gas Cleaning plant and ensure the required measures are implemented to continuously operate the plant. **(ArcelorMittal, ASAP)**

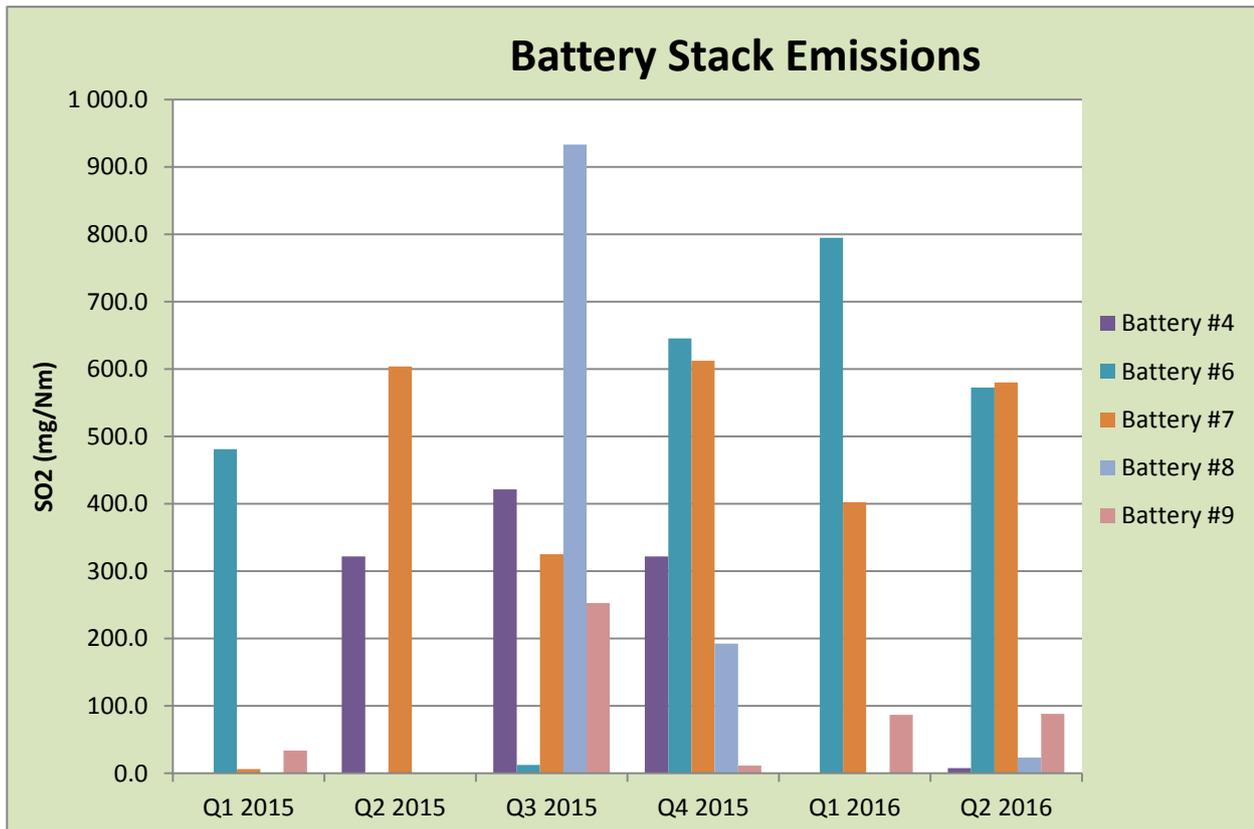
Figure 14: Coke Battery Stacks SO2 emissions (mg/Nm3)

The partially cleaned gas is used as a fuel source at various users within the facility. The coke oven gas is distributed to the users which are able to utilise coke oven gas as energy source. The Coke Batteries are also a major user of the coke oven gas. The gas is combusted and emitted to atmosphere. The coke battery stacks performance in terms of gas and dust is stipulated below;

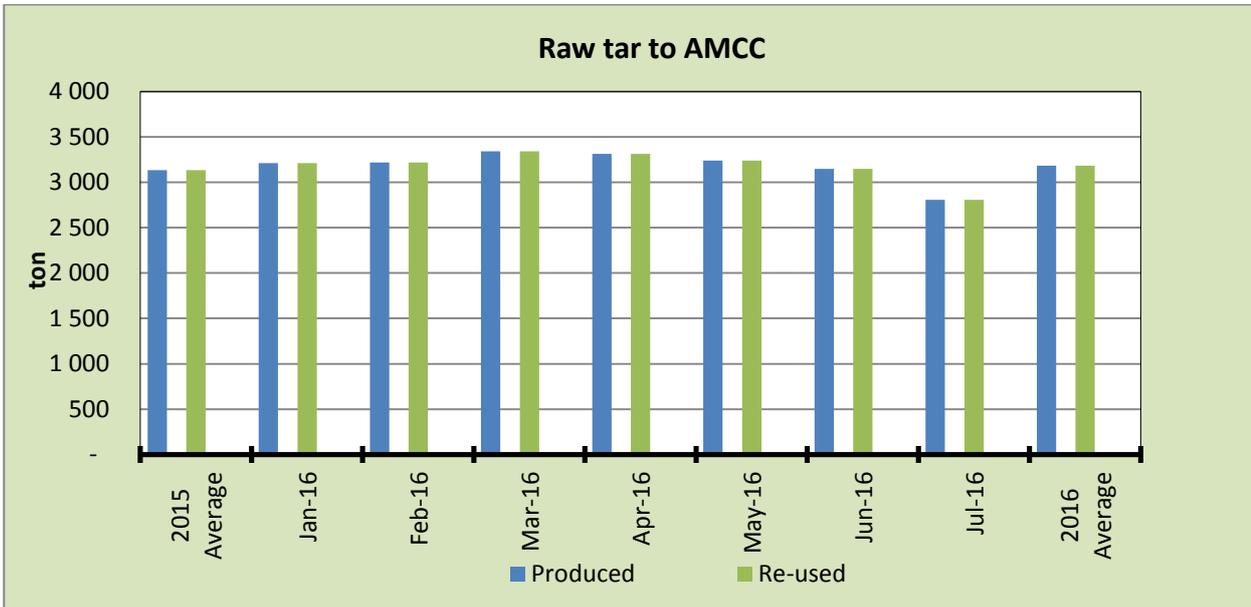
Figure 16: Tar volumes

The Coke Ovens basically generates Coke Breeze, liquid raw tar and tar sludge as by-products and waste streams. Liquid tar generated is pumped to the tar plant for further processing.

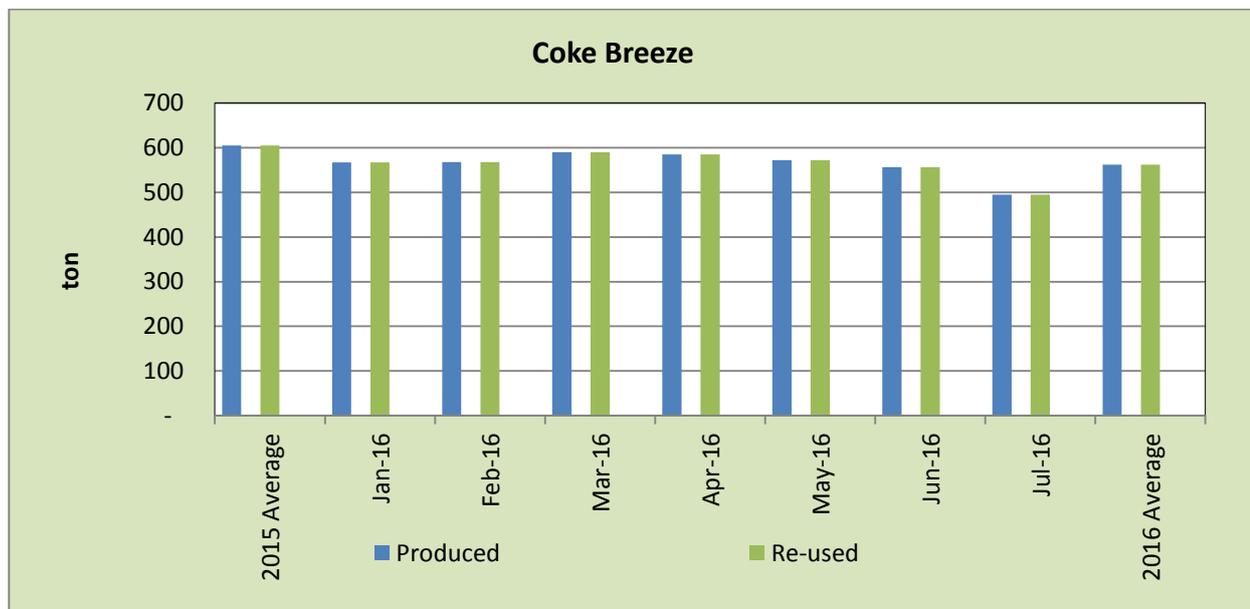
Figure 18 Coke breeze volumes

Coke breeze is generated during the quenching process. Water is sprayed onto the hot coals when it is pushed out of the ovens. The coke breeze collects at the base of the quench tower. Some of the coke breeze is used for mixing with the tar sludge but the larger bulk, approximately 14 200 ton/month is transported by railway to the sinter plant for recycling.

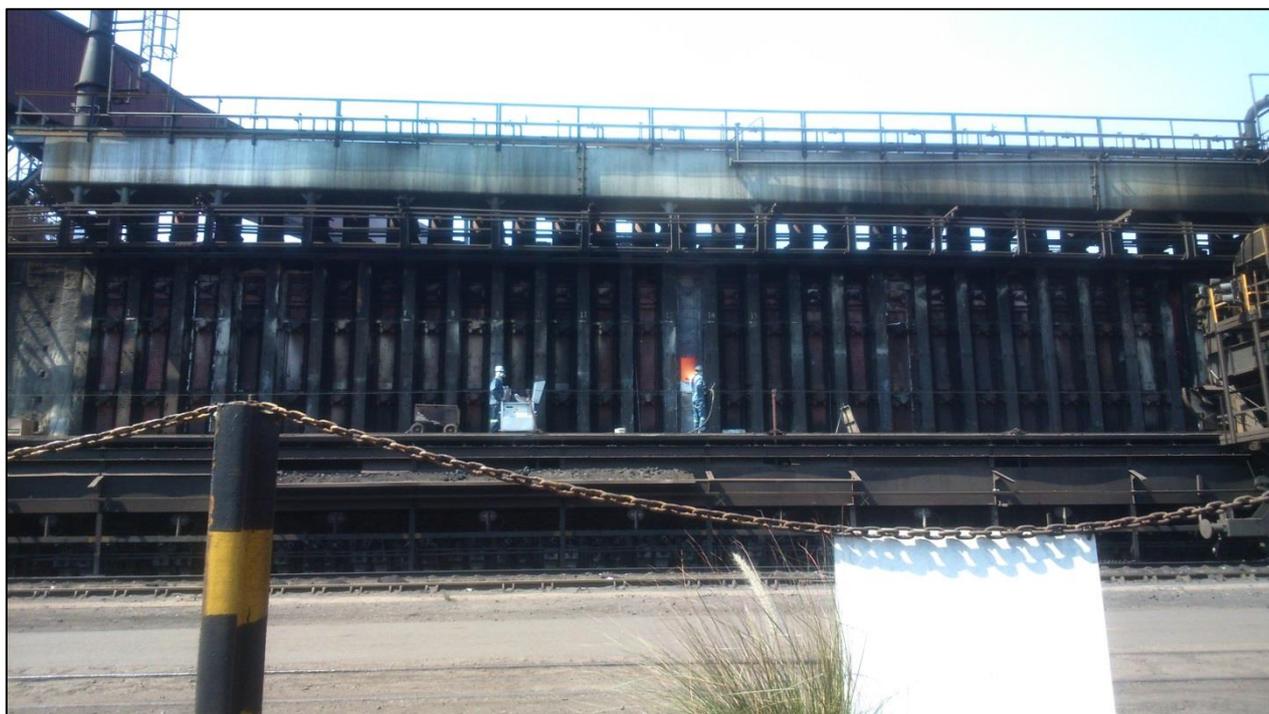
Figure 19: On-going coke oven door maintenance

<u>DEVIATIONS ON INSPECTIONS OF BATTERY DOORS</u>																
	P/S	DOORS	HEADS	CHECK/D	KLIETS	SADDLES	DOOR HOOKS	GUN LINTELS	APRONS	C/S	DOORS	KLIETS	SADDLES	DOOR HOOKS	GUN LINTELS	APRONS
<u>4 BATT INSPECTION</u>	P/S	0	2	4	0	0	0	11	0	C/S	0	4	1	0	1	0
<u>6 BATT INSPECTION</u>	P/S	0	0	0	2	0	0	1	0	C/S	0	1	3	1	6	0
<u>7 BATT INSPECTION</u>	P/S	0	0	2	4	0	0	0	4	C/S	0	11	2	3	3	1
<u>8 BATT INSPECTION</u>	P/S	0	2	4	2	1	0	9	0	C/S	0	4	3	0	14	0
<u>9 BATT INSPECTIONS</u>	P/S	0	6	6	1	2	0	19	0	C/S	1	8	2	0	1	18
TOTAL DEVIATIONS	P/S	0	10	16	9	3	0	40	4	C/S	1	28	11	4	25	19
